# Manhole Inspection Summary

Manhole # S21AA\_040MH

Insp Date: 9/11/07 8:29 AM

**Location** Address: **1609 VINCENT ST**

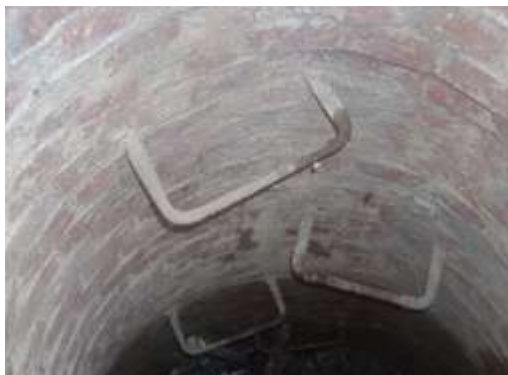
Defect 4

Count: **4** Missing: **0** ☒ **Corroded**

CORRODED STEPS

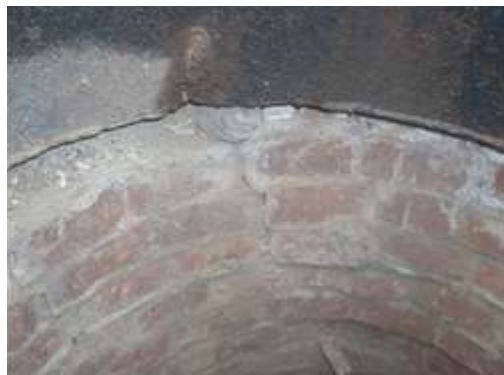
Defect 3

Condition: ☐ Sound ☒ **Cracked** ☐ Root Intrusion ☐ Loose Brick ☒ **Deteriorated**

CRACKED CORBEL

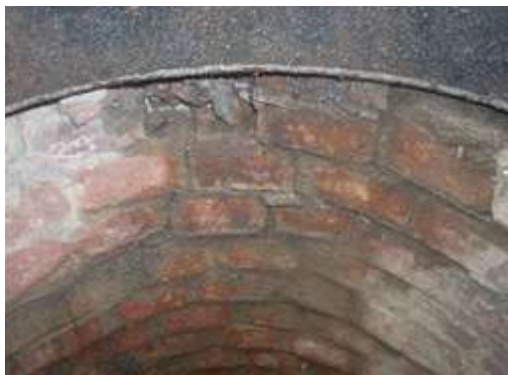
Defect 2

Infiltration: ☐ None ☒ **Joint** ☐ Cracks ☐ Mortar ☐ Roots ☐ Wall

CORBEL DETERIORATION AND INFILTRATION AT THE JOINT

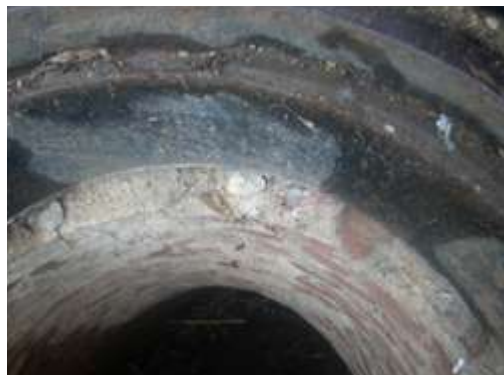
Defect 1

Offset: **2** (in.)

FRAME OFFSET
